KitchenAid Blender 5KSB52 Ultra Power hard rubber coupling Replacement

Kitchen Aid Hard Rubber Coupling for Mixer 5KSB52 Ultra Power. Replace the overcharged, low-performance coupling.

In this guide, we will show you how to replace an overcharged, low-performance hard-rubber coupling in a Kitchen Aid Mixer 5KSB52 UltraPower.

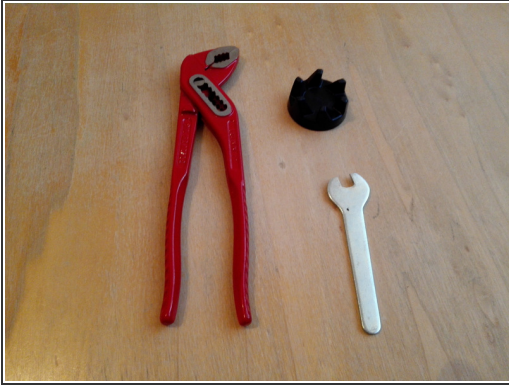
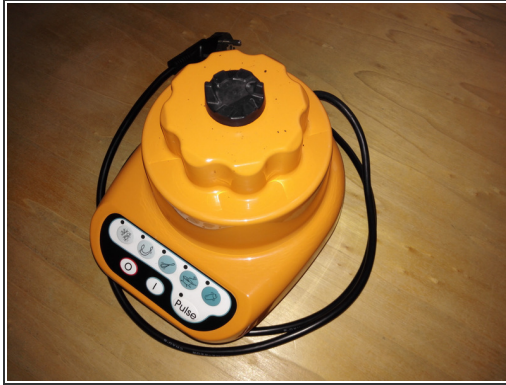
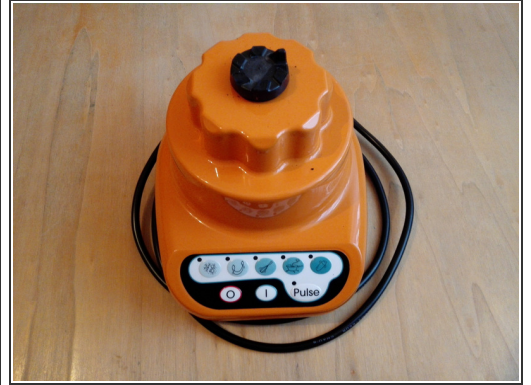
Step 1 — Hard rubber coupling

- Disconnect the blender from the power supply. Prepare tools and spare parts. Tools required: original spanner, small water pump tongs. Spare part: hard rubber coupling

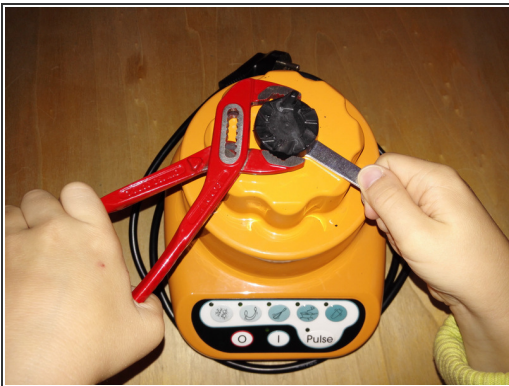
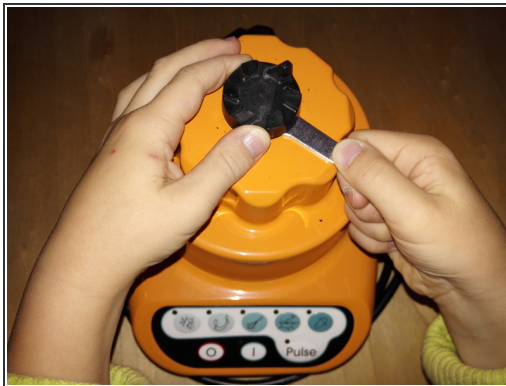
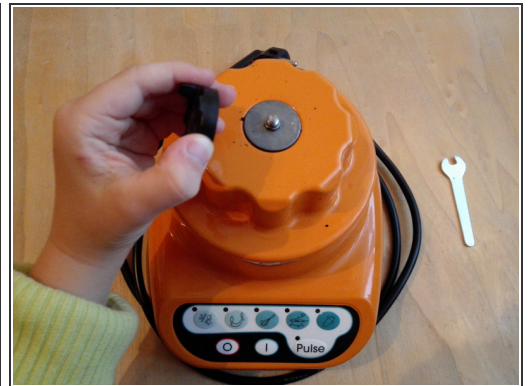
Step 2

- Loosen the defective coupling with water pump tongs and original open-ended spanner. Hold the axis with an open-ended spanner and unscrew the coupling. Remove coupling.

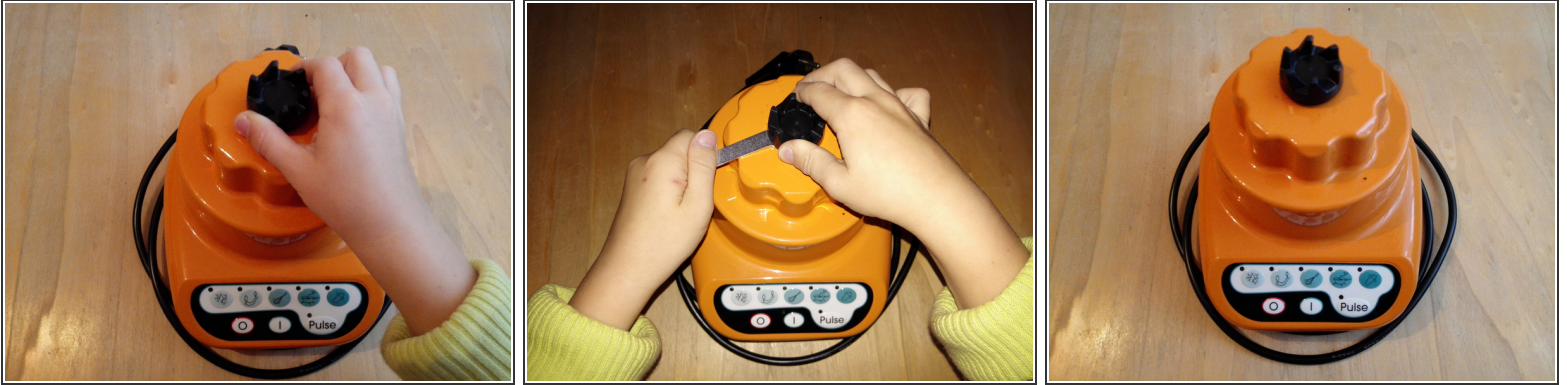
Step 3

- Insert the new coupling and screw it on slightly. Screw the new coupling by hand with a spanner.

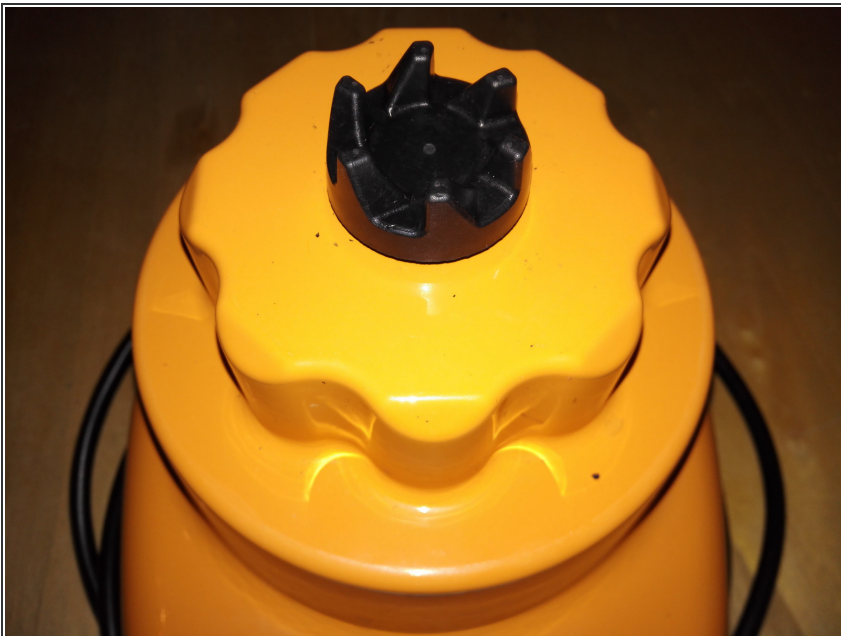
Step 4

- Finished.

Repeat the steps in reverse order to reassemble your device.
